Geomorphic studies of landslides in the Tully Valley, New York: implications for public policy and planning[☆]

Donald L. Pair^{a,*}, William M. Kappel^b

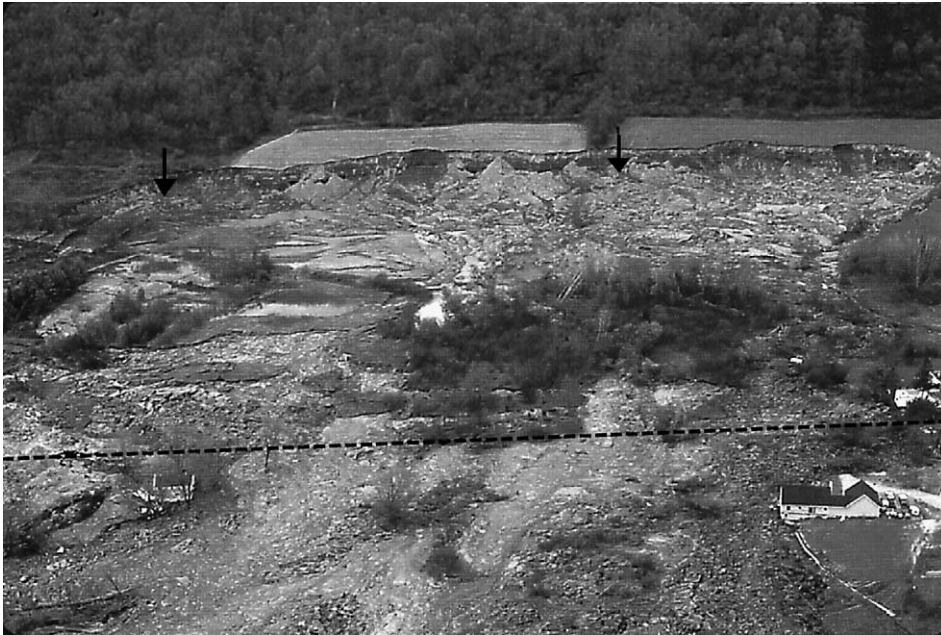
Fig. 2. Oblique view of the 1993 Tully Farms Road landslide taken April 30, 1993, 3 days after the slide. Debris moved towards the viewer and covered Tully Farms Road (dashed line) with as much as 4 m of remolded clay (modified from [Wieczorek et al., 1998](#)).

365 m of Tully Farms Road with as much as 5 m of remolded clay (Kappel et al., 1996; Kappel, 1997) (Fig. 2). Three individuals were rescued from their home by helicopter from the middle of the landslide area. Eventually, 15 homes lost their drinking water supply as a result of changes in local ground-water flow patterns. This paper describes the effects of the 1993 landslide, reports on the results of several follow-up investigations and geomorphic studies, and examines the implications of the landslide for public policy and planning in the Tully Valley community.

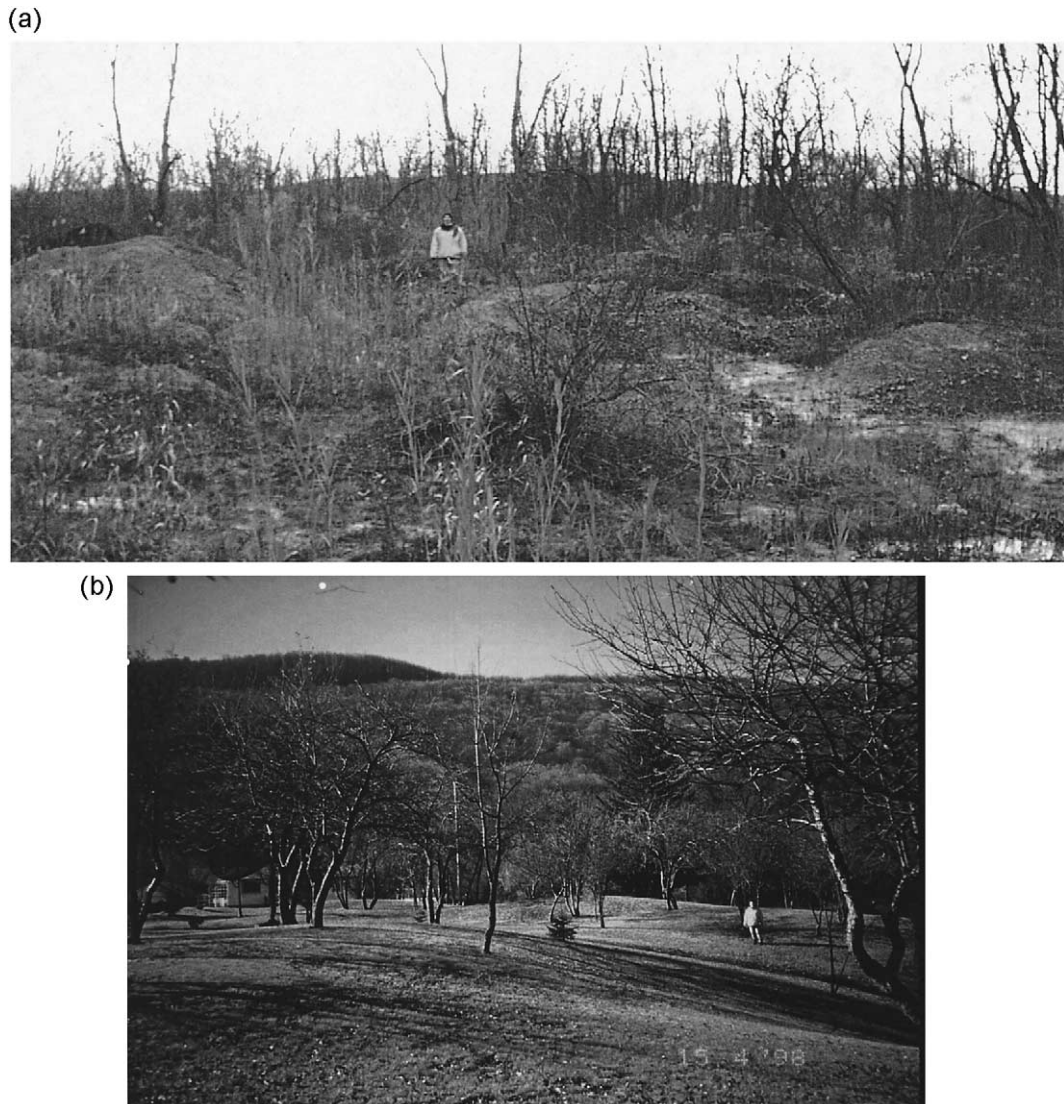
Fig. 4. Hummocks found at the toes of landslides: (a) 1993 Tully Farms Road landslide area; (b) Webster Road landslide areas. Locations are shown in Fig. 3.
